University of Anbar

Effect of Duration and Intensity of Burning on Columns Exposure to Cyclic Fire

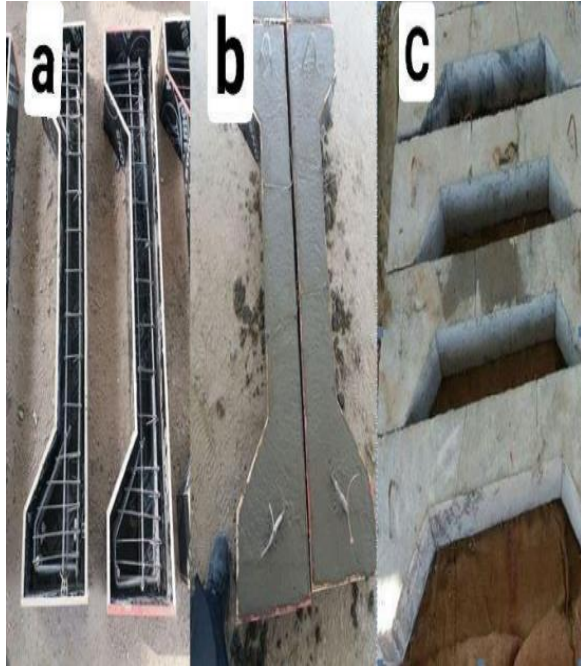
Figure 3. Phases of the casting process

reinforced in solid wooden molds to prevent opening the mold when using the electric vibrator while preparing the columns for casting. An integrated vibrator was used to fill each mold with one layer of concrete, crush it, and then vibrate it for two minutes. As depicted in Figure 3

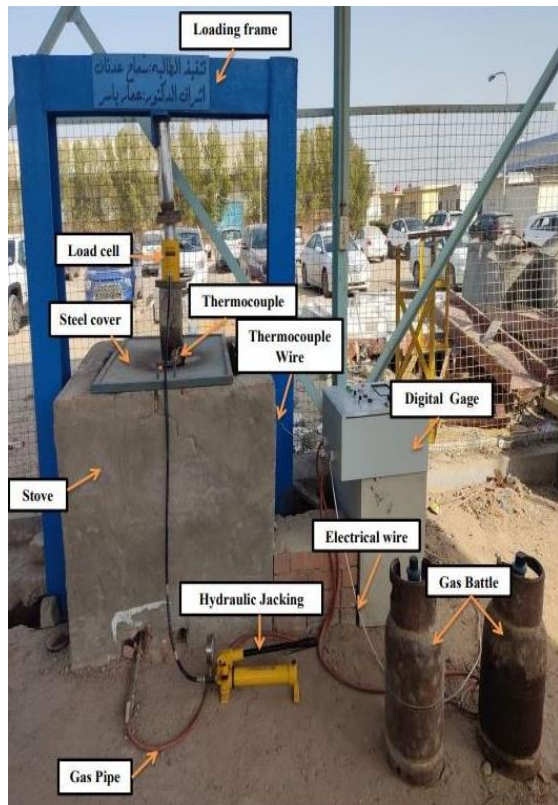
Figure 5 .the act of exposing a fire through the use of pre-loading

- Column "C2" burned four cycles, at a rate of (four days) the inside oven reached a temperature of about "400C". The burning time for each cycles was (45) minutes

- Column "C3" burned four cycles, at a rate of (four days) the inside oven reached a temperature of about "400C". The burning time for each cycles was (75) minutes.

- Column "C4" burned four cycles, at a rate of (four days) the inside oven reached a temperature of about "600C". The burning time for each cycles was (45) minutes.

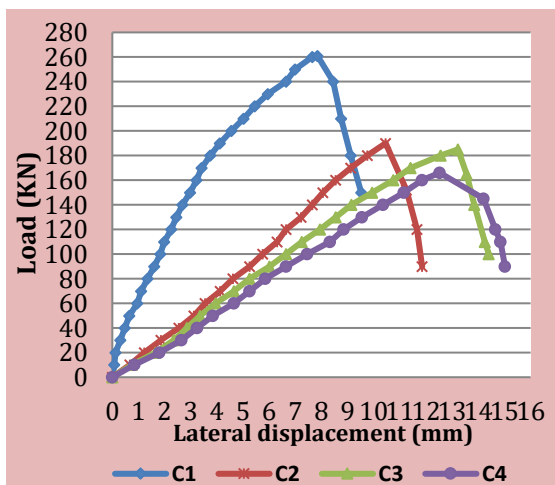
Figure 9. The specimens' load-deflection curves (C1, C2, C3, C4)

This specimen has a cross-section of (150*150), is reinforced with steel bars (4 x 12 mm), has a load eccentricity of ($e = 75$ mm and $e/h = 0.5$), and has a longitudinal reinforcing spacing of (100 mm). Under axial load, the first visible crack is a horizontal crack on the column's top high (80 kN). The unanticipated compression failure occurred at load (261 kN)The curves for lateral displacement and axial deformation are shown in Figure 9.

continuous loading. At hub load, a flat break on the pressure side close to the section's top corbel (25) KN is the main noticeable break. The outer sheathing and torsion of the longitudinal reinforcing bars abruptly failed on the compression side when subjected to a load of (190) kN. Figure9 depicts the lateral displacement and axial deformation curves.

This specimen was burned for four days at a rate of (75) minutes at "400" degrees Celsius. It is made of regular concrete with a cross-section of (150*150) and the load eccentricity of ($e = 75$ mm). It is supported by steel bars (4 x 12 mm) with a longitudinal reinforcing spacing of (100 mm).The outer sheathing and torsion of the longitudinal reinforcing bars abruptly failed on the compression side when the load was (185) kN, and the first obvious crack was on the tension side, close to the column's top corbel (24)KN .Figure 9 depicts the lateral displacement and axial deformation curves.

This specimen was burned for four days at a rate of 45 minutes at "600" degrees Celsius. It is made of regular concrete with a cross-section of (150*150) and the load eccentricity of ($e = 75$ mm). It is supported by steel bars (4 x 12 mm) with a longitudinal reinforcing spacing of (100 mm).The first obvious crack was on the tension side, close to the column's top corbel (22 KN). On the compression side, the outer sheathing and torsion of the longitudinal reinforcing bars abruptly failed under a load of (166) kN. Figure 9 depicts the lateral displacement and axial deformation curves.

The load first crack for column decrease with exposure cyclic fire and increasing duration for burning cyclic and increasing target temperature. The axial and lateral displacement increasing with exposure cyclic fire and increasing duration for burning cyclic and increasing target temperature.
